# Manhole Inspection Summary

Manhole # S21O\_\_012MH

Insp Date: **3/13/08 9:10 AM**

**Location** Address: **600 s payson st**

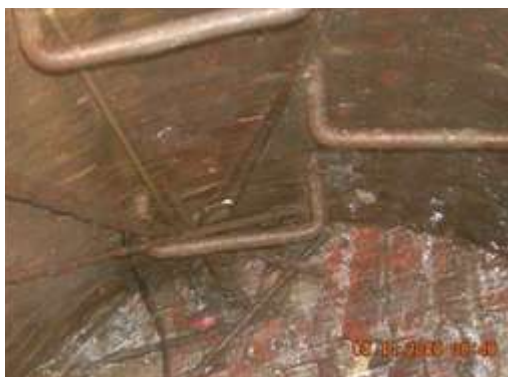
Misc

debris in steps

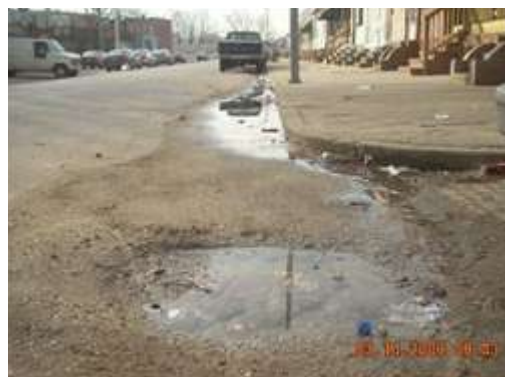
Misc

evidence of ponding

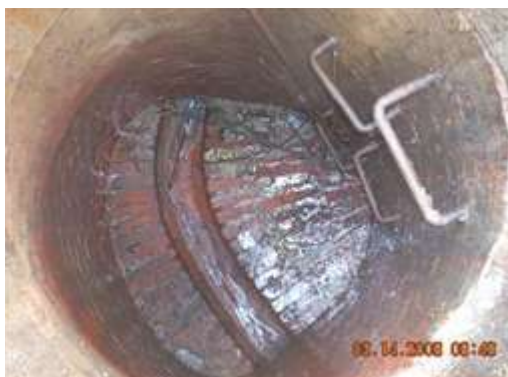
Defect 3

Infiltration: ☐ None ☐ Joint ☐ Cracks ☐ Mortar ☐ Roots ☒ **Wall**

Barrel Flow Wall

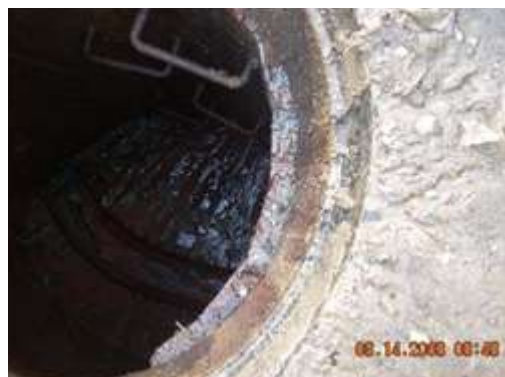
Defect 4

**Frame** Offset: **2** (in.) Condition: ☒ Sound ☐ Cracked ☐ Leaks

frame offset

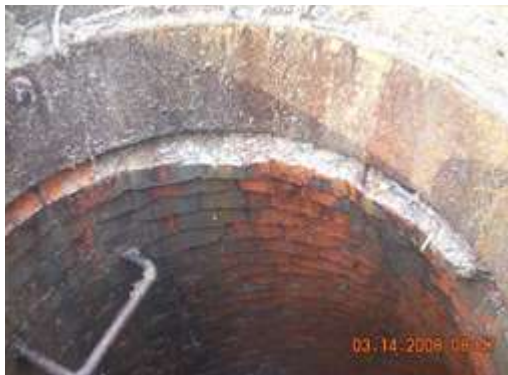
### Defect 2

Infiltration: ☐ None ☒ **Joint** ☐ Cracks ☐ Mortar ☐ Roots ☐ Wall

chimney flow joint

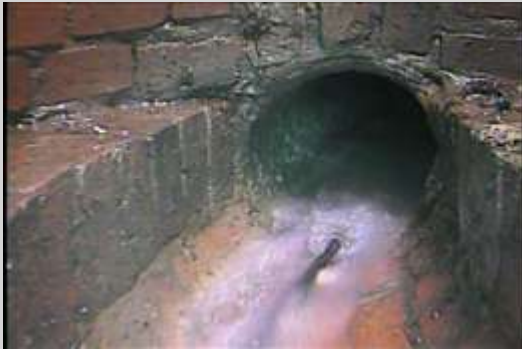
12 O'Clock Outflow

Pipe Height: **8.4** (in.) Rod and Bar (Angled)  
Pipe Material: **Clay** ☐ Pipe Lined  
Invert Depth: **7.52** (ft.) Flow Characteristics: **Slow**  
Deposits: ☐ None ☐ Mud ☐ Sludge ☒ **Debris** ☐ Grease  
Silt Depth: **0** (in.) Deposits Extent: **Light**  
Infiltration: **None** Pipe Seal Cond: **Sound**

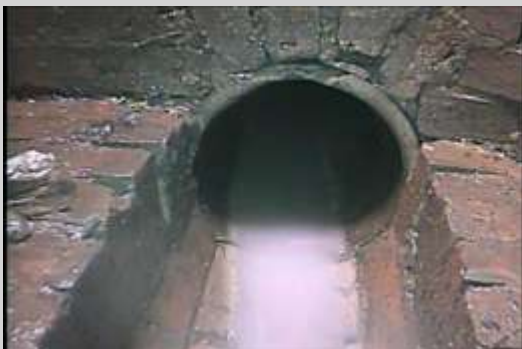
5 O'Clock Inflow

Pipe Height: **8.4** (in.) Rod and Bar (Angled)  
Pipe Material: **Clay** ☐ Pipe Lined  
Invert Depth: **6.94** (ft.) Flow Characteristics: **Slow**  
Deposits: ☒ **None** ☐ Mud ☐ Sludge ☐ Debris ☐ Grease  
Silt Depth: **0** (in.) Deposits Extent:  
Infiltration: **None** Pipe Seal Cond: **Broken**
